Observation of a lightning flashover with a high-speed video camera

Abstract— In this paper we analyze images of a lightning flashover induced by a downward negative lightning flash that struck a transmission line located in São Paulo, Brazil. The lightning flash and the flashover were recorded by a high-speed camera running at 10,000 images per second. The approach of the negative downward leader did not launch an induced positive upward leader prior to the return stroke. One of the AC transmission lines that run over a railway line was struck. The flashover exhibits an oscillatory behavior. The flickering of the image occurs at exactly 120 Hz. The return stroke that struck the line had an estimated peak current of a moderate intensity. It was however, followed by a continuing current lasting 17 ms and an intense M-component that may have contributed to the occurrence of the flashover.

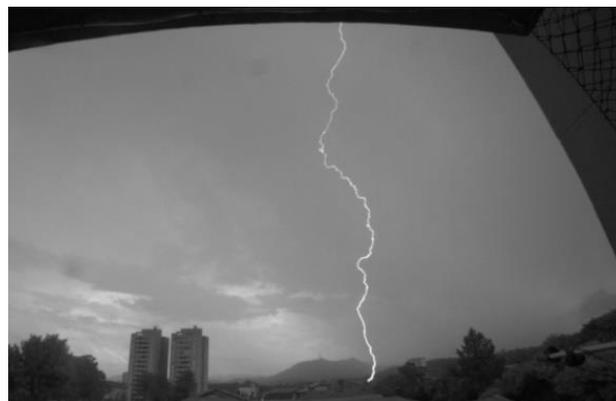
As far as the authors know there are no high-speed video observations of a lightning flash and flashover reported in the literature. This work reports some characteristics of a negative cloud-to-ground lightning that occurred in the city of S. Paulo, Brazil, as shown in Fig. 1, and produced a flashover in an insulator of a transmission line pole.

Figure 1. Negative cloud-to-ground flash that produced a flashover.

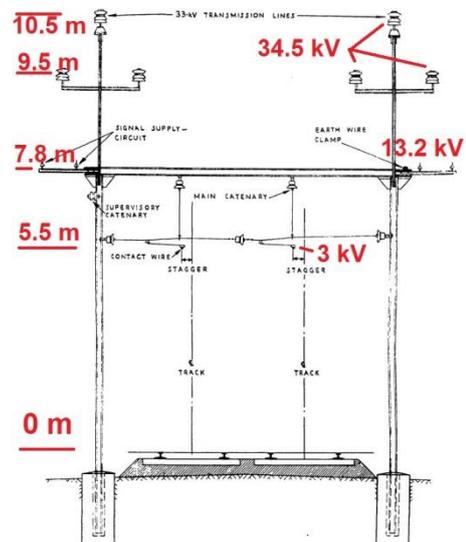
Each pole has three different voltages as shown in Fig. 3: 34.5 kV/60 Hz (three-phase rectifier substation for power supply), 13.2 kV/60 Hz (single-phase line responsible for signaling circuit and for the power supply) and 3 kV DC (power supply for trains). More details on the dimensions of the lines and poles can be found in [2].

Figure 3. Transmission line struck by the lightning flash. Upper image: picture of the transmission lines. Bottom image: sketch of the poles.

b) one of the AC transmission lines was struck. Although the 34.5 kV line is located at the top of the pole (10 m high), as the approach of the leader was not perpendicular to the ground but inclined (Fig. 6), the 13.2 kV line could have been struck. The 13.2 kV line is located at the right side of

the pole and approximately 1.5m below the 34.5 kV line (see Figure 3).

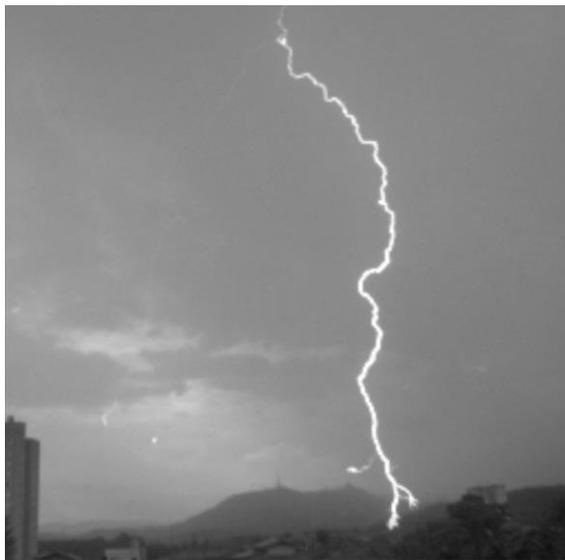
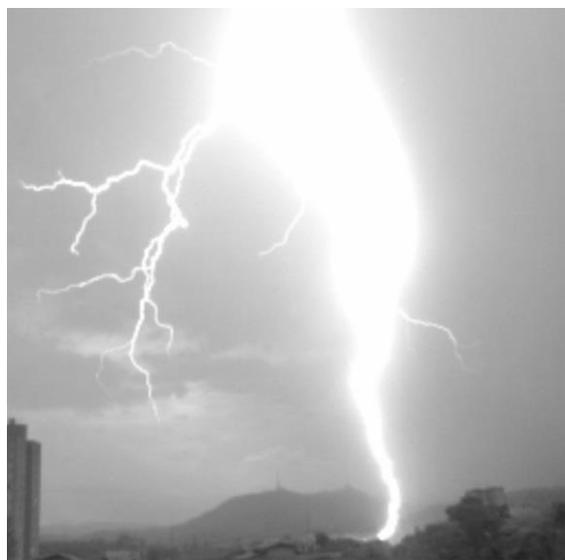
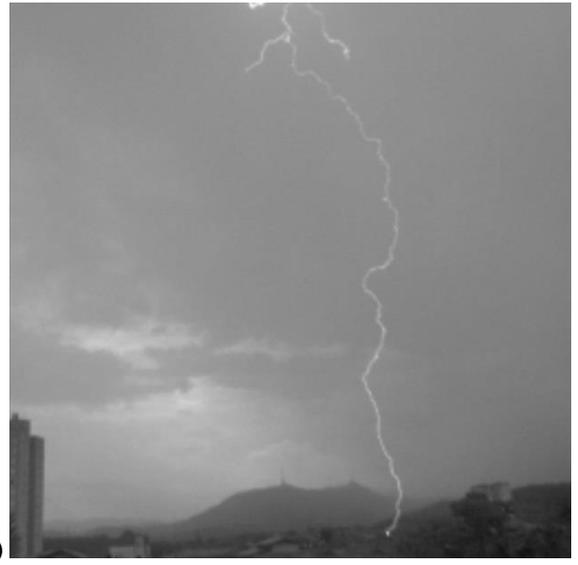
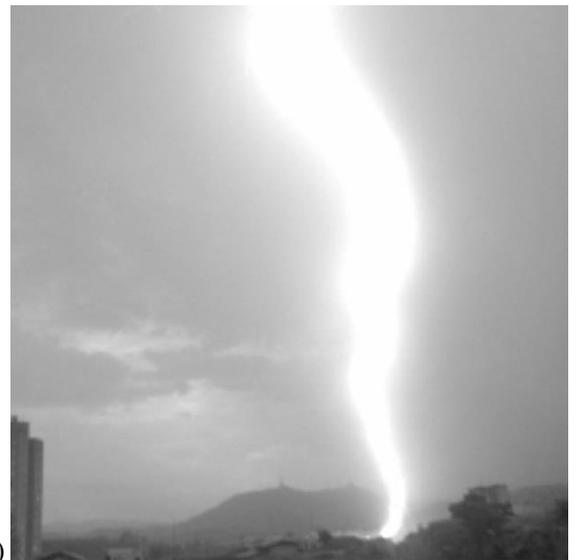
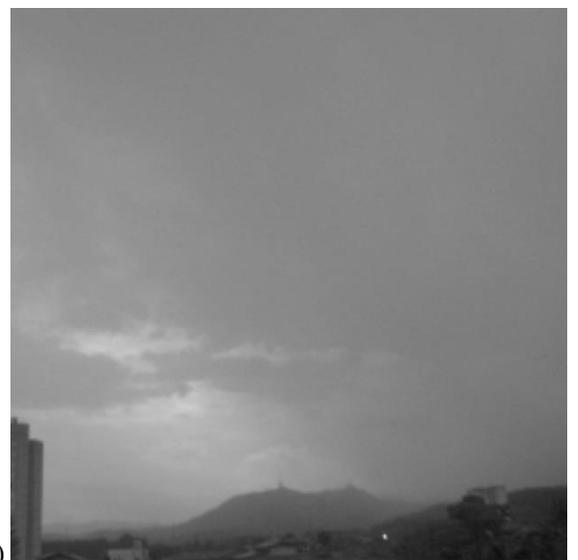
Images of the negative downward leader, the first return stroke, the M-component and the flashover are shown in Fig. 5.

Figure 5. a) downward negative leader, b) almost striking the line, c) return stroke, d) continuing current, e) M-component, f) image of the flashover.
