# Observation of a lightning flashover with a high-speed video camera

**Abstract**— In this paper we analyze images of a lightning flashover induced by a downward negative lightning flash that struck a transmission line located in São Paulo, Brazil. The lightning flash and the flashover were recorded by a high-speed camera running at 10,000 images per second. The approach of the negative downward leader did not launch an induced positive upward leader prior to the return stroke. One of the AC transmission lines that run over a railway line was struck. The flashover exhibits an oscillatory behavior. The flickering of the image occurs at exactly 120 Hz. The return stroke that struck the line had an estimated peak current of a moderate intensity. It was however, followed by a continuing current lasting 17 ms and an intense M-component that may have contributed to the occurrence of the flashover.

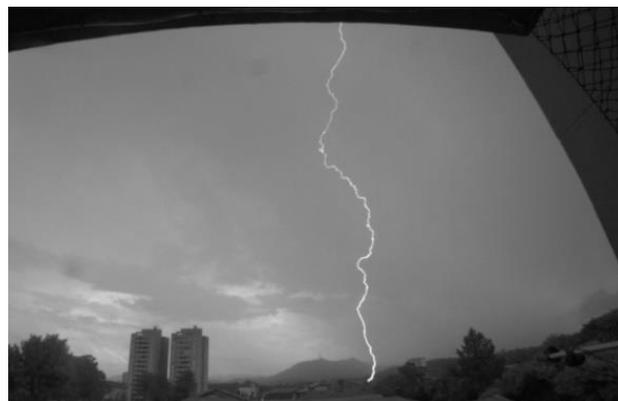
Figure 1. Negative cloud-to-ground flash that produced a flashover.

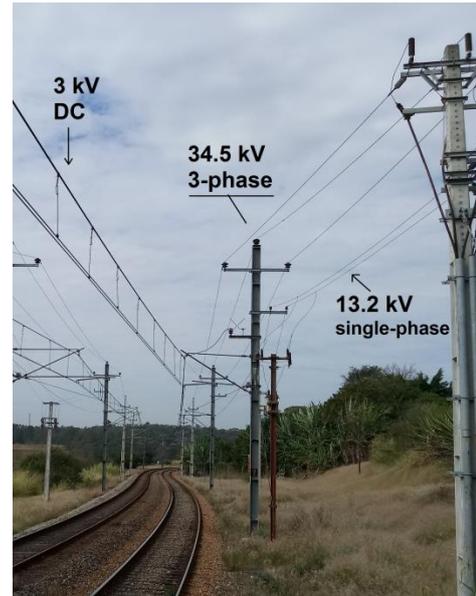
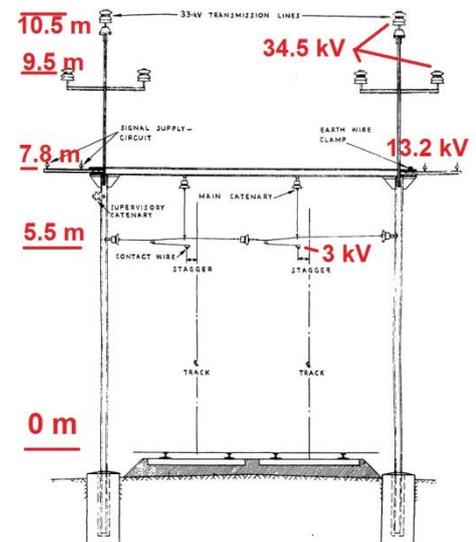
Figure 3. Transmission line struck by the lightning flash. Upper image: picture of the transmission lines. Bottom image: sketch of the poles.

b) one of the AC transmission lines was struck. Although the 34.5 kV line is located at the top of the pole (10 m high), as the approach of the leader was not perpendicular to the ground but inclined (Fig. 6), the 13.2 kV line could have been struck. The 13.2 kV line is located at the right side of

the pole and approximately 1.5m below the 34.5 kV line (see Figure 3).

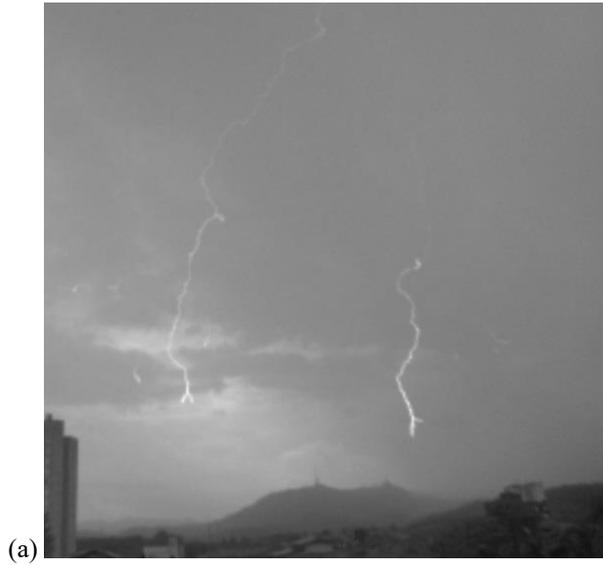
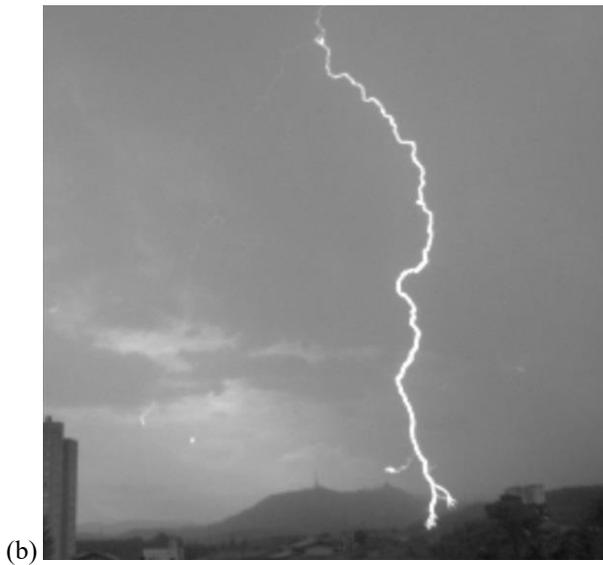
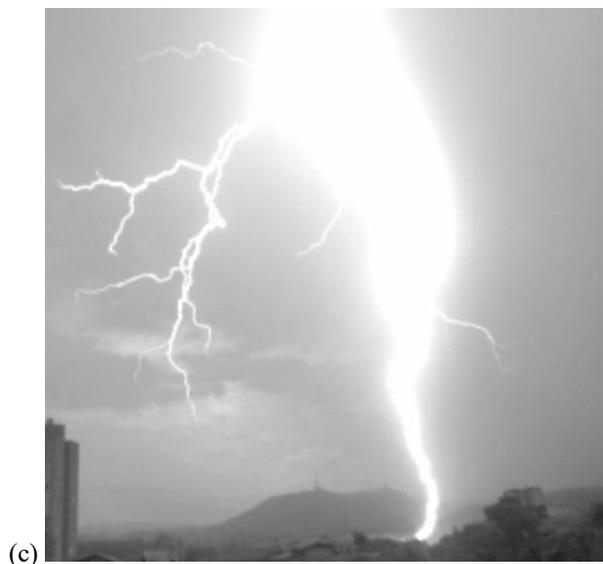
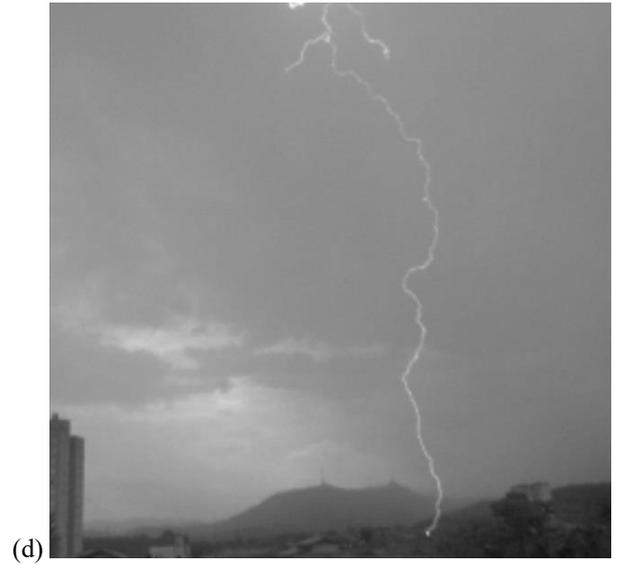
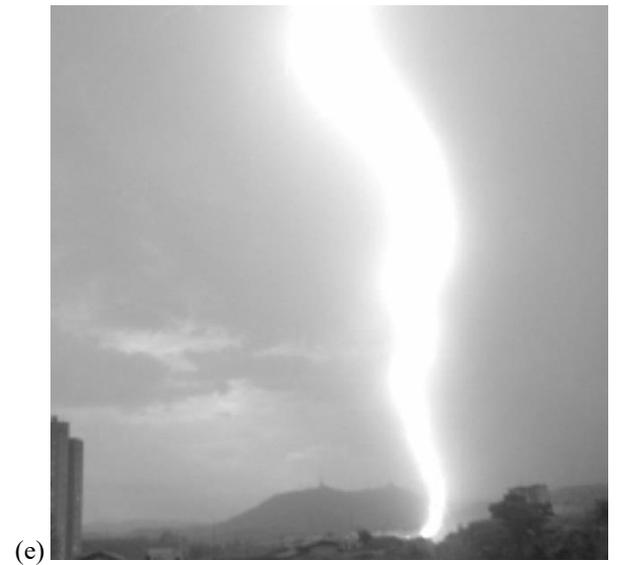
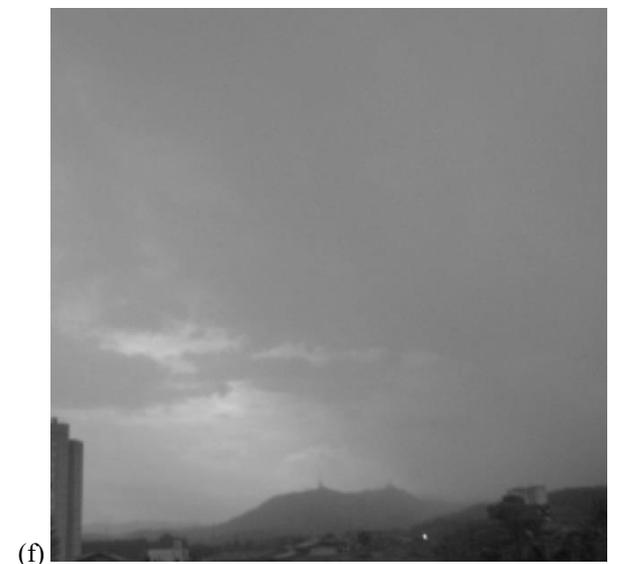
Images of the negative downward leader, the first return stroke, the M-component and the flashover are shown in Fig. 5.

Figure 5. a) downward negative leader, b) almost striking the line, c) return stroke, d) continuing current, e) M-component, f) image of the flashover.

d) The return stroke that struck the line had an estimated peak current of a moderate intensity (-18 kA). However, the presence of a continuing current lasting 17 ms and an intense M-component (estimated peak current of -7 kA), may have contributed to the occurrence of the flashover.

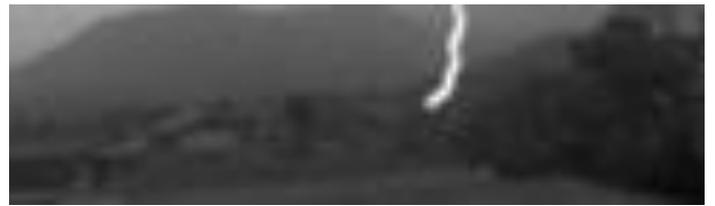
Figure 7. Zoom image of the lightning channel shown in Fig. 1.
