Article

# Monitoring the Vulnerability of the Dam and Dikes in Germano Iron Mining Area after the Collapse of the Tailings Dam of Fundão (Mariana-MG, Brazil) Using DInSAR Techniques with TerraSAR-X Data

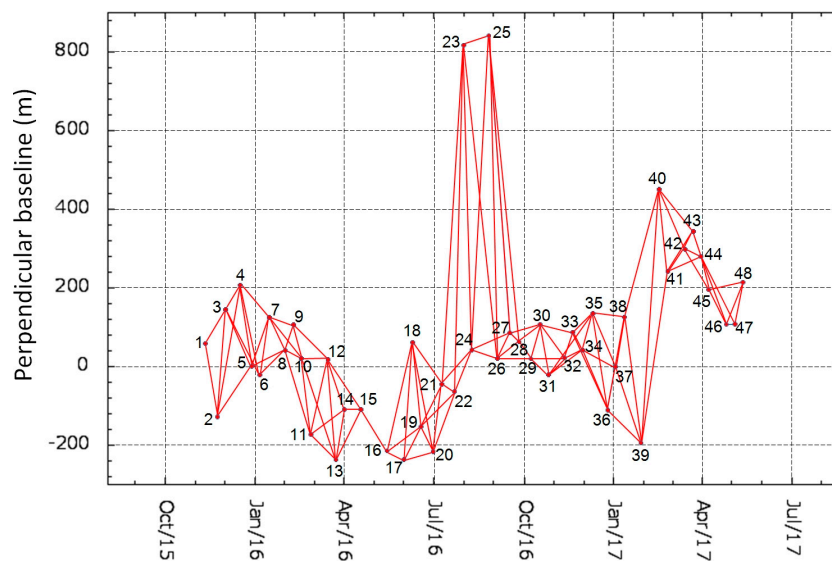
Figure 4. Baselines used to generate interferograms for SBAS processing.

An adaptive spectral filter with a window size of  $32 \times 32$  was applied to the interferograms to generate interferometric coherence images [32]. Regions with coherence below 0.5 were masked out (especially in vegetated areas around the study area). The spatial phase unwrapping of the interferograms was carried out using the MCF (Minimum Cost Flow) algorithm [33]. Visual inspection was also used to discard interferograms with compromising phase unwrapping errors.

The results of the SBAS based on the interferometric pairs configuration are shown in Figure 4, providing information regarding the displacement velocity (Figure 6) and the digital elevation error (Figure 7). These results were used as preliminary information to perform the PSI analysis.

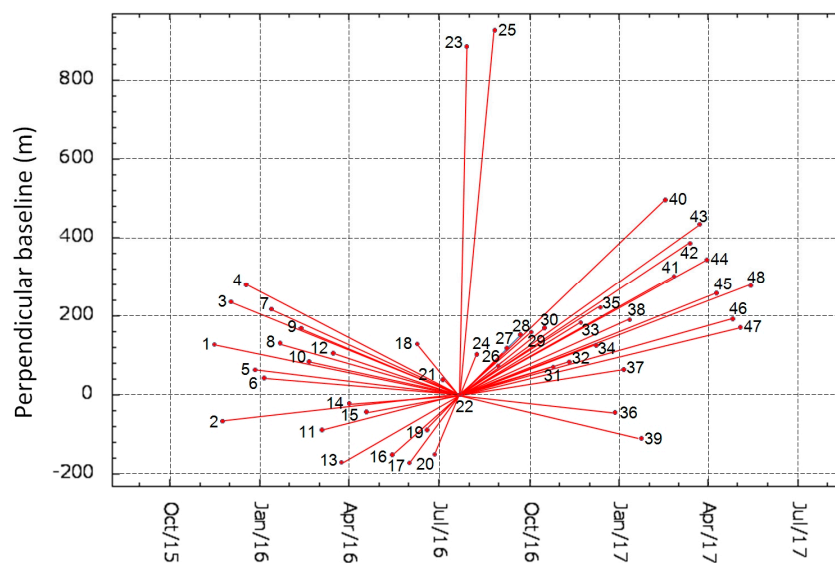
Figure 5. Normal Baselines used for the PSI analysis (reference acquired on 22 July 2016).

PSI analysis was performed using the IPTA module approach [12], i.e., the approach implemented in GAMMA RS software. The topographic error was estimated based on a linear dependence of the topographic phase to the perpendicular baseline components, presenting diversity values from  $-173.16$  up to  $914.83$  m for the 48 pairs, as shown in Figure 5.

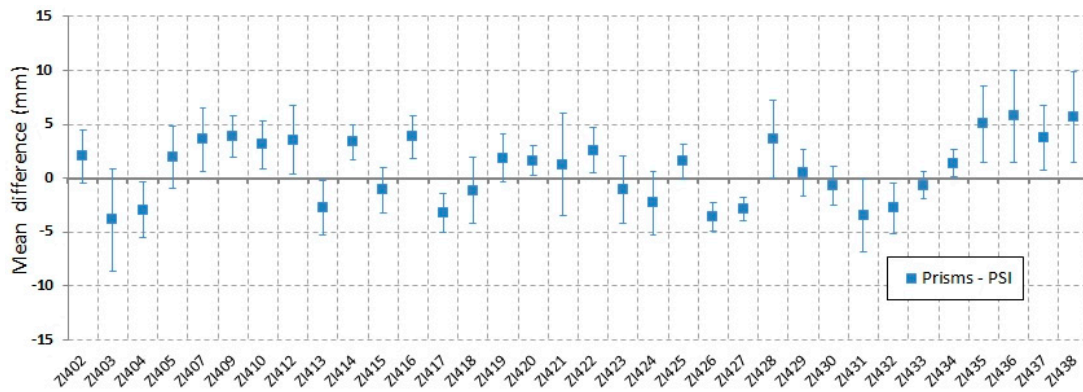
A box plot of the mean difference and standard deviations of the measurements (topographic minus PSI), performed during the period of 11 November, 2015 to 15 May 2017, is shown in Figure 12. Some points (ZI403, ZI431, ZI435, ZI436, ZI437, and ZI438) presented significant discrepancy between the two methods. This could be explained by the intrinsic errors of the topographic data collection (including adverse weather conditions, dust and haze during dry and wet seasons impairing the visibility among station and prisms, distinct operator teams, etc.), the intrinsic errors of the PSI processing, as well as the PS positioning that does not exactly match the prisms (the PS selection was based on the nearest neighbor of the prism).

**Figure 12.** Mean difference and the standard deviation between the measurements of the two methods (Prisms minus PSI) during the period of 11 November 2015 to 15 May 2017 for the 34 points analysed in the main Germano dam.

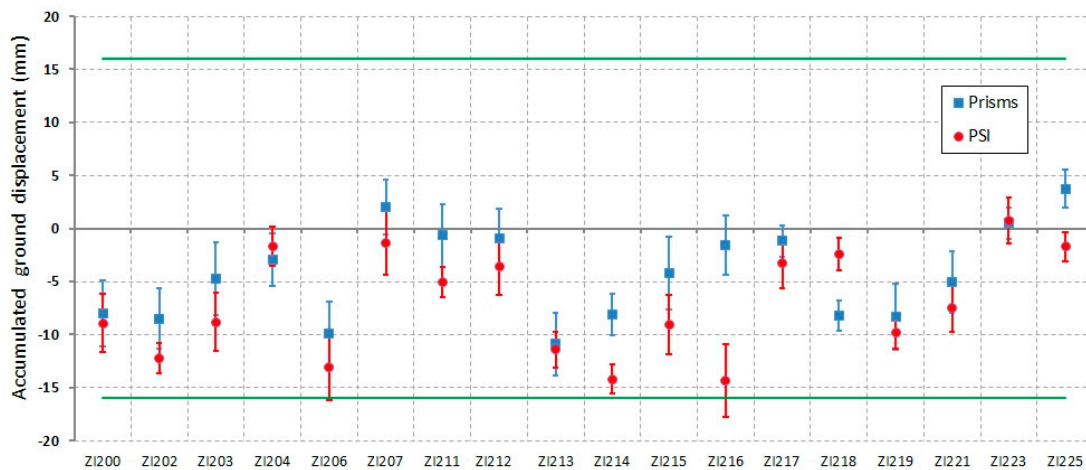
Figure 14 shows a box plot of the accumulated displacement and standard deviations for the 18 points monitored with robotic station and the PSI results in Sela & Tulipa dike, performed during the period of 11 November 2015 to 15 May 2017. All prisms presented accumulated displacement within the error limit ( $\pm 16$  mm). PSI results also exhibited low accumulated displacements for the 18 PS analyzed (closed to the prisms positions), showing values also within the error limits.

**Figure 14.** Accumulated displacements from 11 November 2015 to 15 May 2017 for prisms (robotic station) and corresponding PS (closed to the prisms positions) and its related standard deviations in the Sela & Tulipa dike. The error bar limits ( $\pm 16$  mm) are shown in green.

Several points in the Sela & Tulipa dike (ZI200, ZI202, ZI206, ZI2013, ZI214, ZI215, ZI216, and ZI219) presented a more pronounced ground displacement for both measurements techniques, but were still within the error limits. This could be explained by the fact that after the disaster, this dike was reinforced, and the material placed on it had been compacted during the period of the analysis. This fact did not compromise the stability of this structure, according to the geotechnical team of the SAMARCO Company (Mariana, Brazil).

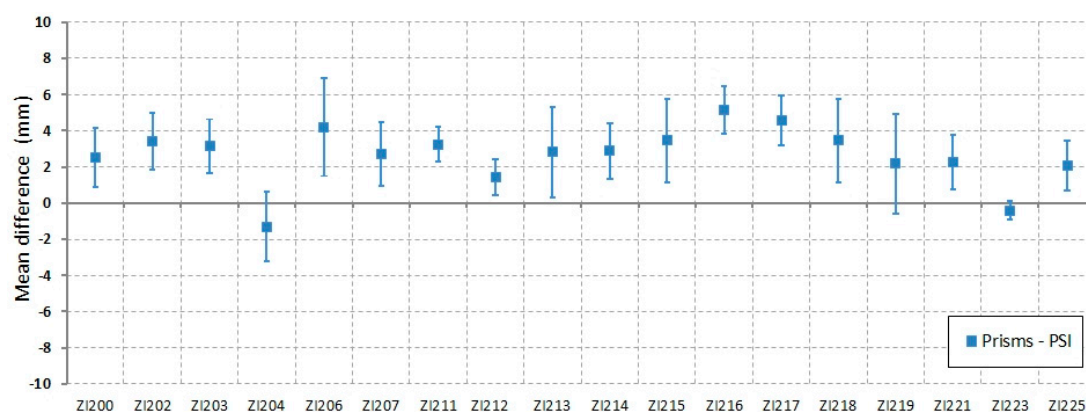
A box plot of the mean difference and standard deviation of the measurements (topographic minus PSI) performed during the period of 11 November 2015 to 15 May 2017 is shown in Figure 15 for the Sela & Tulipa dike. Some points (ZI206, ZI216 and ZI217) presented significant discrepancy in mean value difference between the two methods; a possible reason for this was already explained for the results presented the Figure 12. It can be noticed in Figure 15 that the mean values of the differences are slightly smaller than those shown in Figure 12, probably due to the denser grid of PS in the wall of Sela & Tulipa dike, meaning smaller distances between prisms and PS positions.

**Figure 15.** Mean difference and the standard deviation between the measurements of the two methods (Prisms minus PSI) for the 34 points analysed in the Sela & Tulipa dike.

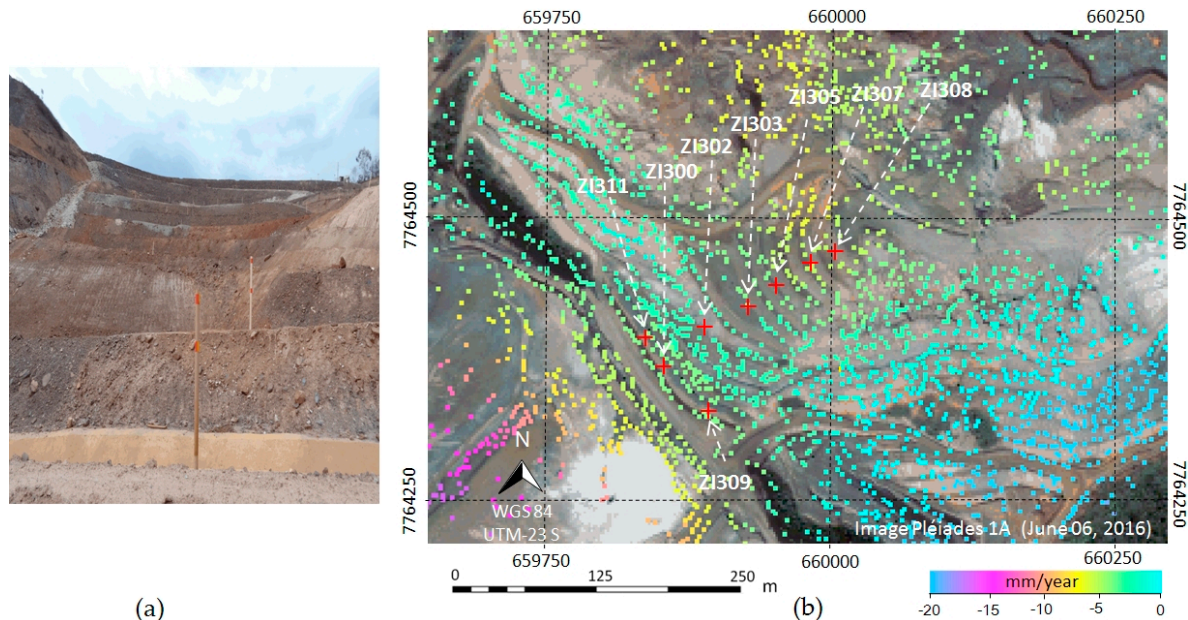
The Selinha dike is shown in Figure 16, with a field picture of the wall (a) and the ground displacement map of the dike and surrounding area, with the location of 8 points of field topographic measurements (b). The comparison between the topographic measurements and the PSI results are presented in Figure 17.

**Figure 16.** Field picture of the wall of the Selinha dike (a) and the ground displacement map derived from PSI analysis showing the positions of the prisms (b).

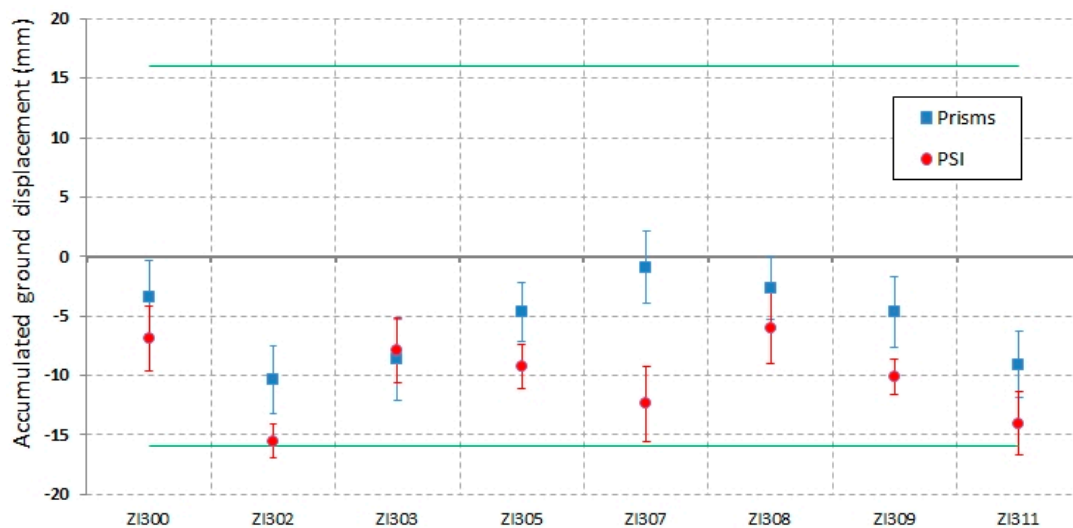
**Figure 17.** Accumulated displacement from 11 November 2015 to 15 May 2017 for prisms (robotic station) correspond to PS (closed to the prisms positions) and its related standard deviations in the Selinha dike. The error bar limits ( $\pm 16$  mm) are shown in green.

Several points in the Selinha dike (ZI302, ZI303, ZI305, ZI307, ZI309, and ZI311) presented a clear accumulated ground displacement. The causes of these behaviors can be explained due to the structural reinforcement works implemented in the dyke after the disaster, with material showing compaction during the period of the analysis. This fact did not modify the stability conditions of this structure, according to the geotechnical team of the SAMARCO Company.

The points ZI302, ZI307, and ZI311 presented accumulated ground displacement near to the error limit for the PSI analysis (Figure 17), overestimating the ground displacement in relation to the prism measurements. It can be noted in Figure 18 that the mean values of the differences are slightly greater than those presented in Figures 12 and 15, probably due to the sparser grid of PS along the wall of Selinha dike.

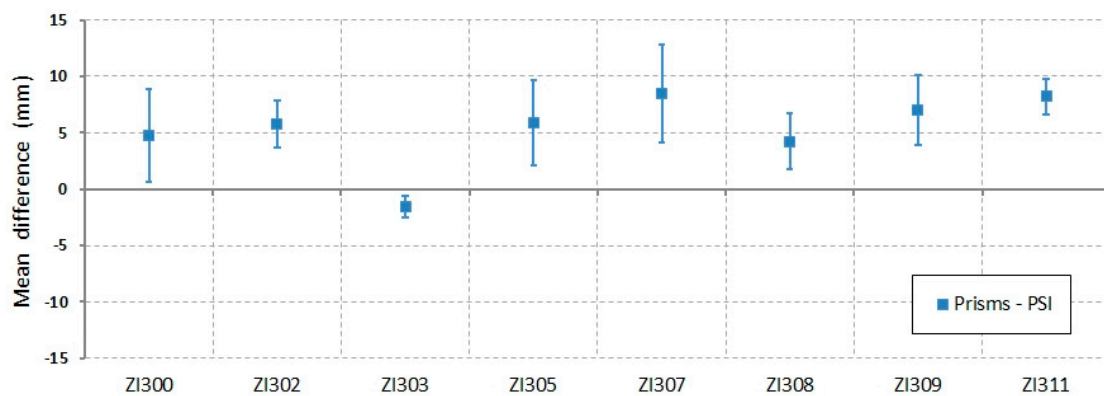
Box plot of the mean difference and standard deviation of the measurements (topographic minus PSI) performed during the period of 11 November 2015 to 15 May 2017 is shown in Figure 17 for Selinha dike. All prisms presented accumulated displacement within the error limits. PSI results also exhibited low accumulated displacement for the 8 PS analyzed (closed to the prisms positions), showing values within the error limits. The results shown in Figure 17 are indicative of stability in the Selinha dike during the time interval of the analysis, according to the criterion of the error limit ( $\pm 16$  mm).

**Figure 18.** Mean difference and the standard deviation between the measurements of the two methods (Prisms minus PSI) for the 34 points analysed in the Selinha dike.

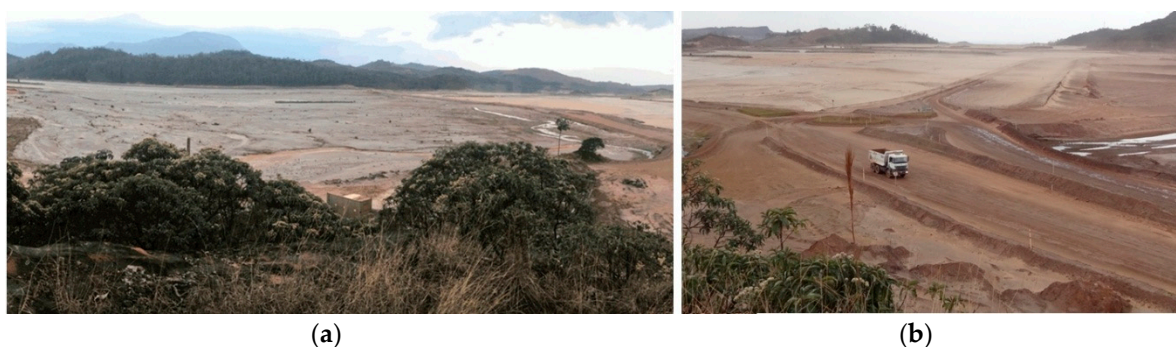
The sectors D and E of the study area, as shown in Figure 8, are related to auxiliary dikes and the reservoir. The dikes are supporting structures which serve to delimit the areas for tailings impoundment, allow proper handling material, and are also used as access routes. Since no deposition of material occurred after the Fundão rupture, the soils within the reservoir underwent an overall compaction (settlement). In addition, compaction also occurred along the auxiliary dikes due to continuous traffic of trucks and heavy equipment. Figure 19 shows field pictures of the Baía 3 dam and its reservoir and the auxiliary dike that is used for trunk movements and monitoring.

**Figure 19.** Field picture of the Baía 3 dam and its reservoir (a) and the auxiliary dike that cross the Germano reservoir (b).

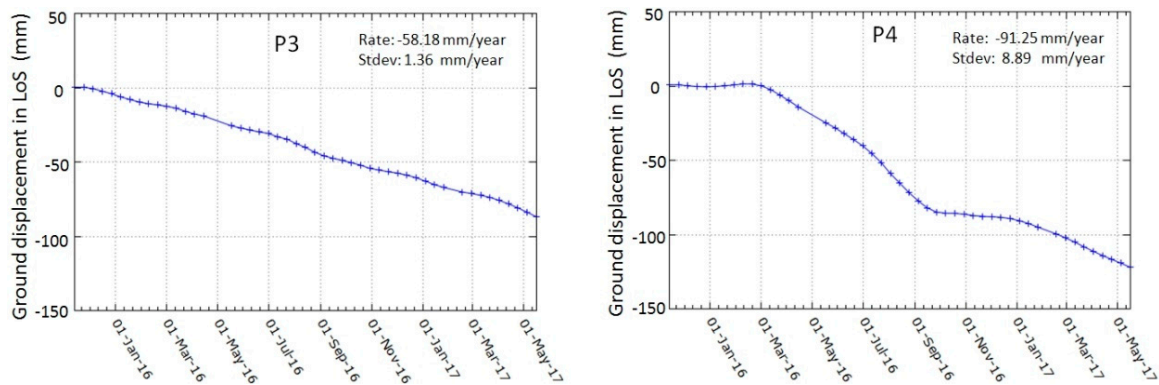
Graphs of the accumulated ground displacement are shown in Figure 21 for the point P1 and P2, with accumulated values of  $-49.52$  and  $-82.06$  mm, respectively, and in Figure 22 for the point P3 and P4, with accumulated values of  $-80.43$  and  $-125.67$  mm, respectively.

**Figure 22.** PSI results of the ground displacement in LoS of the points P3 and P4 in the auxiliary dike and reservoir of Baía 3, respectively.

The criterion for the selection of the points P1, P2, and P3 was based only on their location on the auxiliary dikes, and on significant degree of subsidence. Point P4 was selected in a position within the reservoir of Baía 3 that presented a high degree of subsidence. Auxiliary dikes were built with a compact mixture of sand and silt-sized particles in roughly equal proportion, in order to withstand heavy vehicle traffic. The Baía 3 reservoir is composed by fine tailings (mud), being more affected by the terrain accommodation. Since no deposition of material occurred after the Fundão rupture, the soils underwent an overall compaction (settlement), affecting the auxiliary dikes and reservoir in different ways, depending on the material used in their creation. Points P1, P2, and P3 presented a quite linear behavior of deformation (Figures 21 and 22), probably due to the same type of material used on auxiliary dikes constructions (Figure 20), as opposed to the mud filled reservoir where P4 is located (Figure 20) presenting a high nonlinear ground displacement (Figure 22).

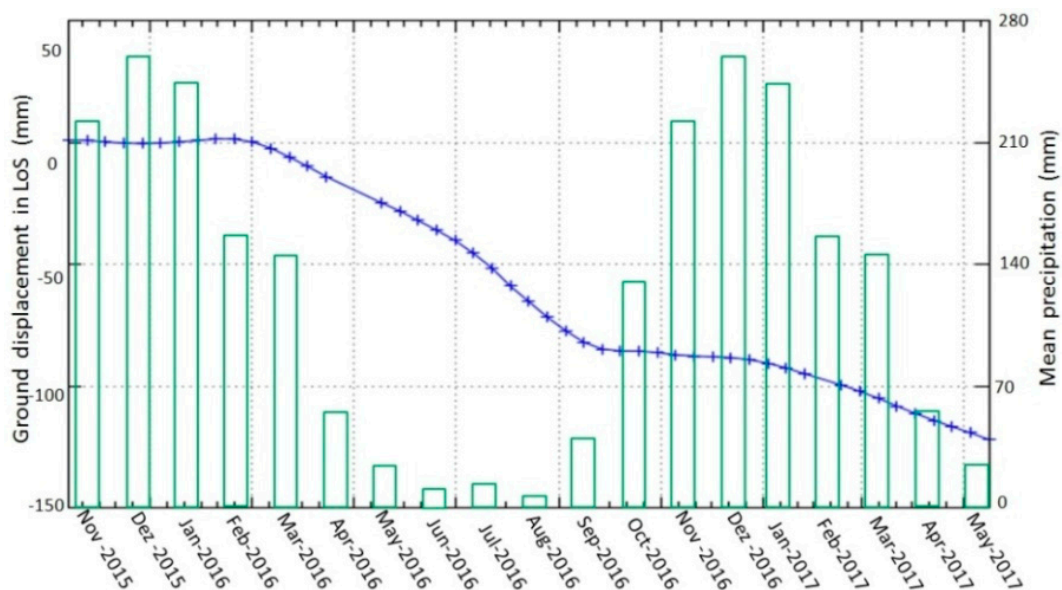
Figure 23 shows the ground displacement of the point P4 in the Baía 3 reservoir and its relationship with the annual average precipitation in Mariana-MG municipality [35] during the period of the A-DInSAR analysis. It can be noted in Figure 23 that the ground displacement increases during the dry season due to the process of the soil compaction (dry mud) within the Baía 3 reservoir, being less accentuated during the wet season.

**Figure 23.** PSI results of the ground displacement in LoS of the point P4 in the reservoir of Baía 3 versus the mean precipitation during the period of November 2015 up to May 2017.
